NASA TN D-6981

PERFORMANCE OF 40-MILLIMETER-BORE  
BALL BEARINGS WITH LEAD- AND  
LEAD-ALLOY-PLATED RETAINERS IN  
LIQUID HYDROGEN AT 1.2 MILLION DN

*by David E. Brewe, Donald W. Wisander,  
and Herbert W. Scibbe*

*Lewis Research Center  
Cleveland, Ohio 44135*

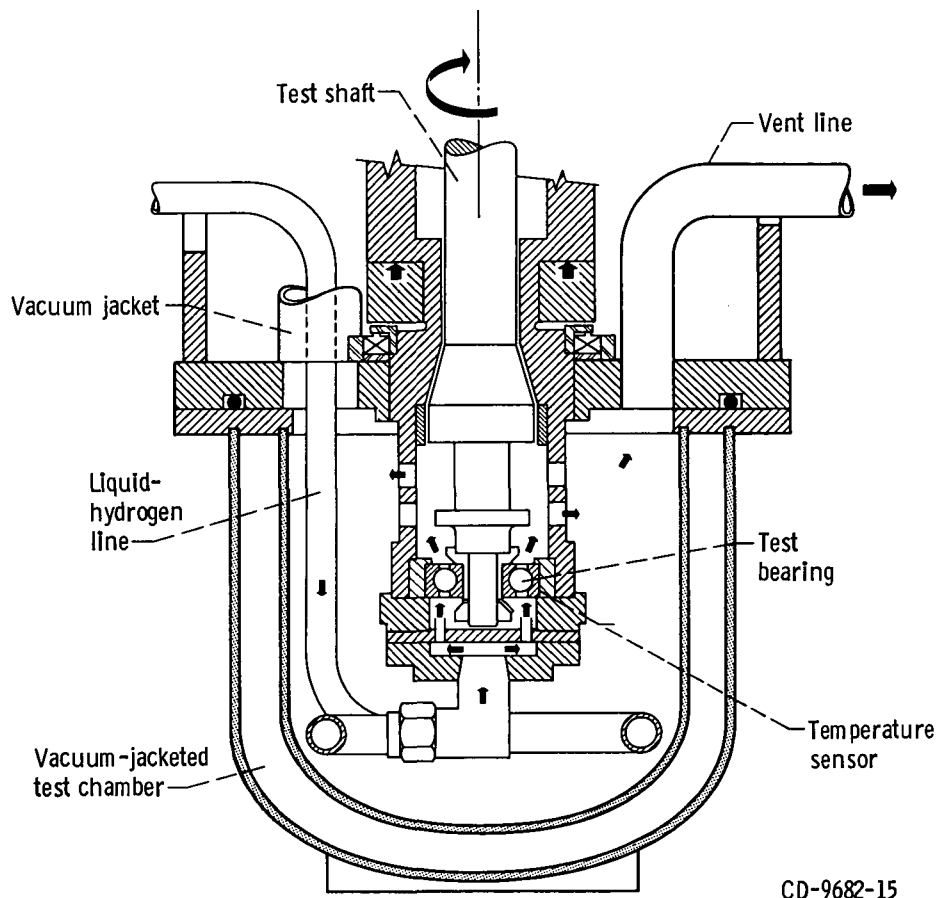
The test apparatus is shown in figure 1. The test bearing was driven through a gear assembly by a variable-speed, direct-current motor. Automatic speed control (to within  $\pm 0.1$  percent) was provided over a range of test-shaft speeds from 900 to 30 000 rpm. The test shaft was supported at its lower end by the test bearing and at its upper end by an oil-lubricated ball bearing. Thrust load was applied to the test-bearing housing by a deadweight load. A schematic view of the test-bearing mounting and support housing is shown in figure 1. The test-bearing outer-race temperature was monitored with a platinum resistance sensor (fig. 1) and continuously recorded on a strip chart. Speed was indicated on a digital frequency meter. Motor power consumption was determined from readings of a voltmeter and an ammeter (armature power).

Figure 1. - Liquid-hydrogen bearing test apparatus.

The test bearing (fig. 1) was cooled by liquid hydrogen supplied from a 1.89-cubic-meter (500-gal) Dewar. The liquid-hydrogen flow rate to the test bearing was approximately 0.0076 cubic meter per minute (2 gal/min). The liquid-hydrogen flow from the Dewar was regulated by the Dewar pressure and the flow valve setting.

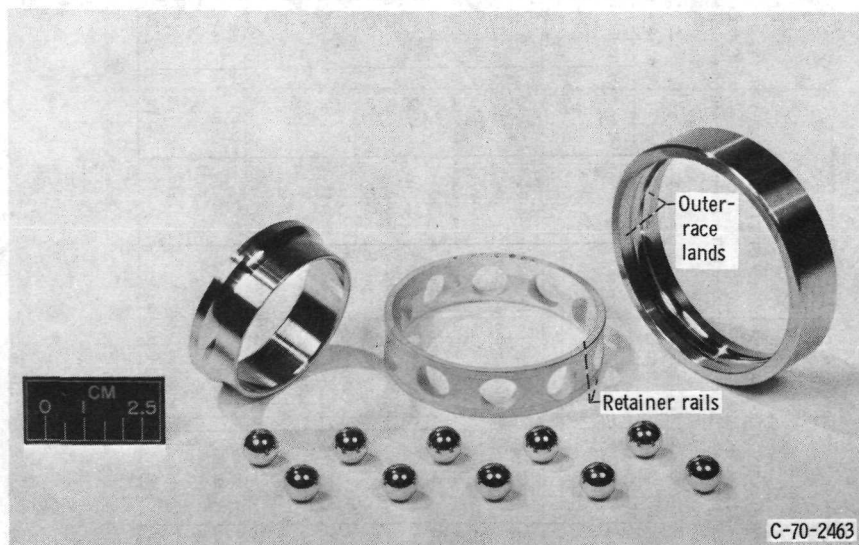
The retainers were outer-race located and of one-piece construction machined from one of four different substrate materials. Composition and hardness of substrates are given in table I. The retainer locating surfaces were two raised rails or lands, as shown in figure 2. The rails were approximately 2 millimeters (0.080 in.) wide and 0.2 millimeter (0.008 in.) high. The diametral clearance of the retainer rail with the outer-race shoulder (i.e., the land clearance) ranged from 0.53 to 0.79 millimeter (0.021 to 0.032 in.), whereas the ball pocket clearance ranged from 0.48 to 0.76 millimeter (0.019 to 0.030 in.) as indicated in table II.

Figure 2. - Typical outer-race riding retainer and bearing (bearing 12). Retainer material, hard aluminum-bronze alloy; coating material, 70-percent-lead - 30-percent-indium alloy; thickness of coating, 34.4 micrometers.

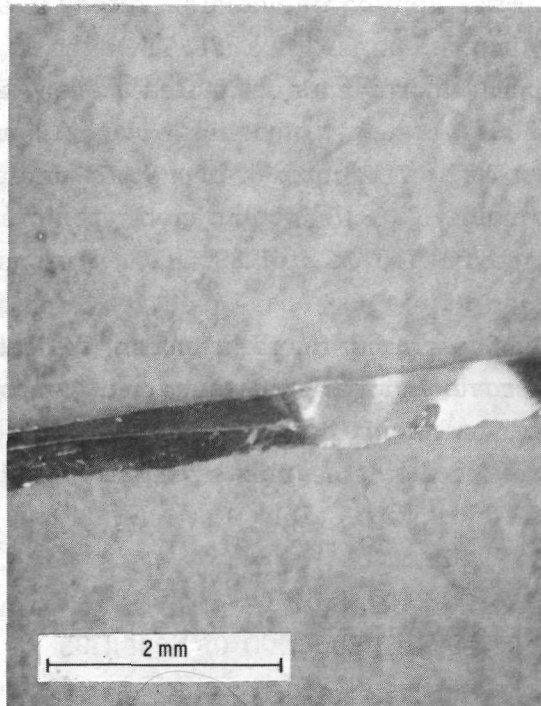
A 12.4-hour run time was obtained with bearing 7. The lead-transfer film thickness on bearing 7 was excessive and caused the lead to blister and peel off in ribbons as shown in figure 3. The retainer substrate used for bearing 7 was a hard aluminum-

Figure 3. - Ribbon of lead transfer film removed from outer-race ball track of bearing 7 after 12.4 hours of run time.

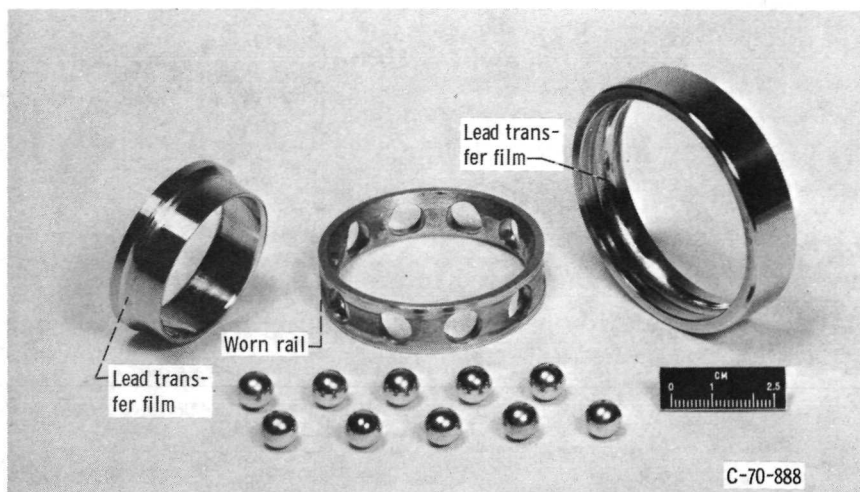
bronze alloy (material D, table I) with a 38-micrometer- (0.0015-in.-) thick lead coating. Visually, wear of the retainer substrate material from the rail area had occurred mostly on one side of the retainer (see also fig. 4). Lead smearing back onto the rail wear areas from adjacent areas of the outer diameter of the retainer may have contributed to the longer useful life of bearing 7. The results from reference 4 and

Figure 4. - Bearing 7 after 12.4 hours of run time at 30 000 rpm. Retainer material, hard aluminum-bronze alloy; coating material, pure (99.9 percent) ion-plated lead; thickness of coating, 35.8 micrometers.

Thicker lead coatings were plated on the harder aluminum-bronze retainers of bearings 6 and 7 than were used on the softer aluminum-bronze retainers of bearings 1 and 2. Bearing 6 failed catastrophically after running 2.7 hours at 30 000 rpm. There was evidence of abnormal wear on the upper areas of the ball pockets. Bearing 7, however, completed 12.4 hours of run time. Running was discontinued when the retainer rails began to show excessive wear (see fig. 4). The other bearing components were still in good condition.

Generally, wear on the retainer rails was uneven around the periphery. Wear and deformation in the ball pockets was quite high as illustrated in figure 4 for bearing 7. The retainers of bearings 2, 5, 7, 8, 10, 11, 13, and 15 all had high, uneven wear. These retainers had more than 2-percent weight loss for their total running times.

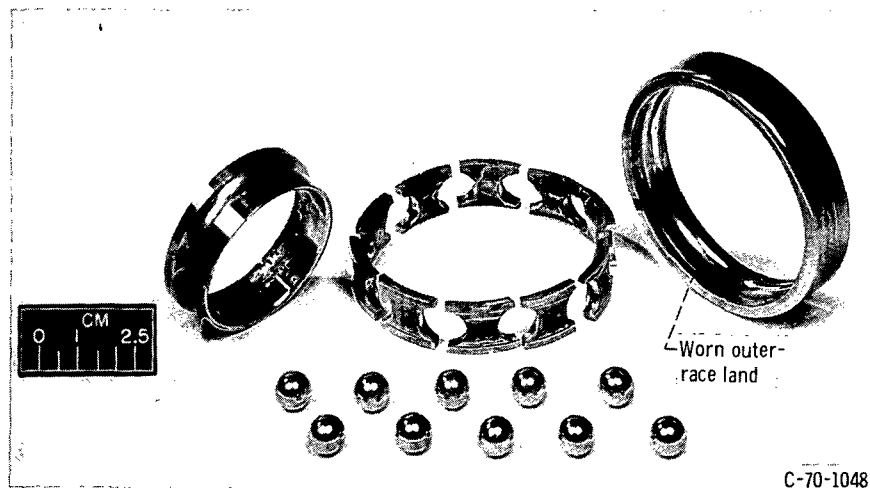
As shown in figure 5, the retainer of bearing 8 fractured through the ball pockets after running 6.7 hours. Postrun examination indicated that the retainer rails had worn deeply into the bearing outer-race lands, while the retainer and the coating had experienced little wear. Apparently, the hard phase (undissolved antimony) acted as an abrasive and wore the locating shoulders of the hardened 440C stainless steel outer race.

Figure 5. - Failure of bearing 8 after 6.7 hours of run time at 30 000 rpm. Retainer material, AISI 440C stainless steel; coating material, 97-percent-lead - 3-percent-antimony alloy; thickness of coating, 49.5 micrometers.

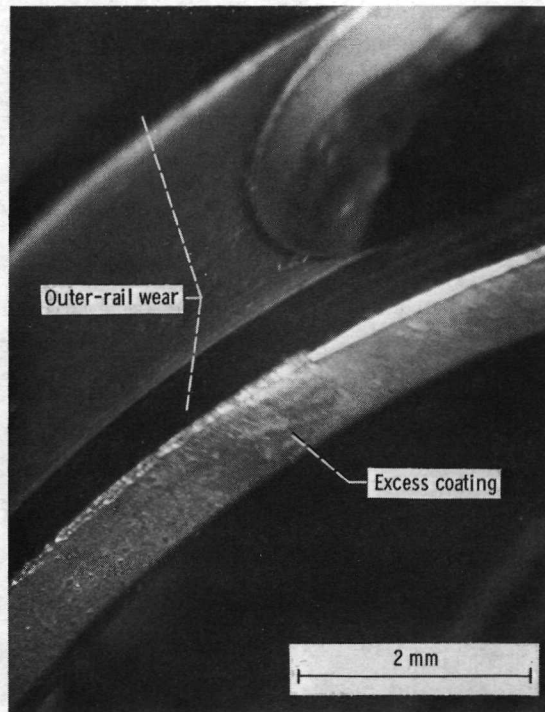
than the melting point of the lead-indium alloy. Therefore, some of the coating ran as it was applied, and the result was a nonuniform coating thickness. This uneven distribution of the coating resulted in an unbalanced retainer. Postrun inspection showed that most of the retainer rail wear occurred on the rail adjacent to the heavily coated end, as shown in figure 6.

Figure 6. - Retainer showing uneven coating thickness and rail wear after 4 hours of run time (from bearing 12). Coating material, 70-percent-lead - 30-percent-indium alloy.

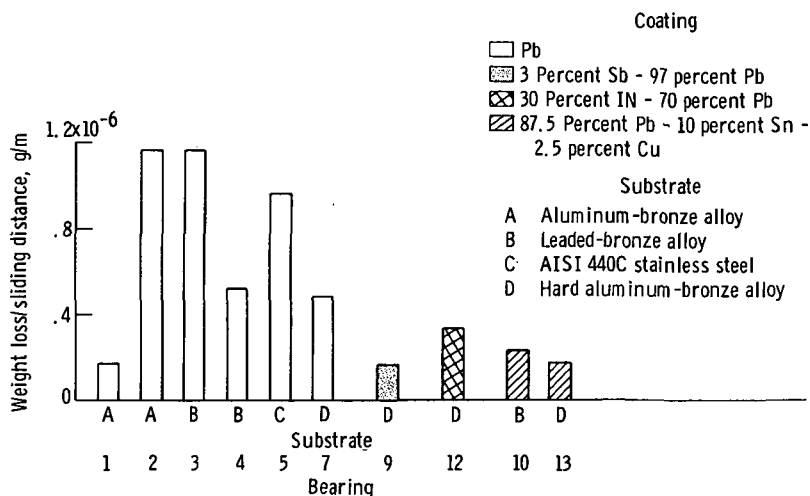
The wear rate of the various retainer coating and substrate materials can be compared by observing the bar graph in figure 7. Bearings that failed as a result of a

Figure 7. - Retainer weight loss per unit sliding distance for various coated retainer-substrate materials.

broken retainer or peeled coating were excluded from the plot. The lead-alloy coated retainers had lower wear rates than those with the pure-lead coating. Of the bearings shown in figure 7, only 1, 9, and 12 accurately represent coating wear since these retainers had minimal substrate wear. Retainer 7, with lead coating, and retainers 10 and 13, with lead-tin-copper-alloy coating, achieved the required 10-hour life with relatively low wear rates. The leaded-bronze alloy (material B) or the aluminum-bronze alloy (material D) served equally well as retainer substrate materials.
